# TECHNICAL INSPECTION OF BUILDING STRUCTURES OF A FOUR-STORY BUILDING IN CONNECTION WITH RECONSTRUCTION AND RE-PROFILING FOR A HOTEL COMPLEX

Subject building - block "B".

Block B - four-story building, sizes B plan 71.2x24.0m. B axes "1-14/A-D."

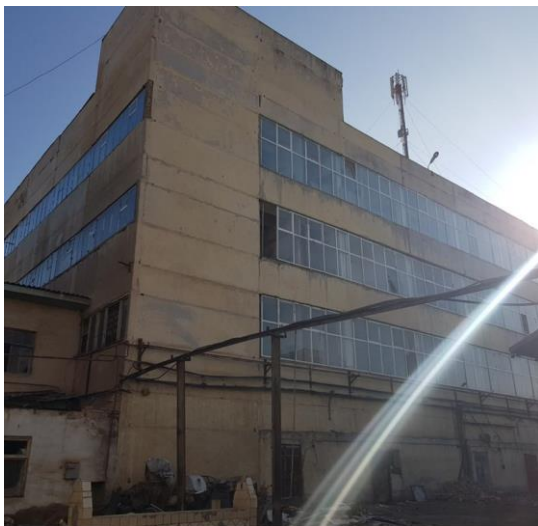
Figure 1 - Exterior view of the building

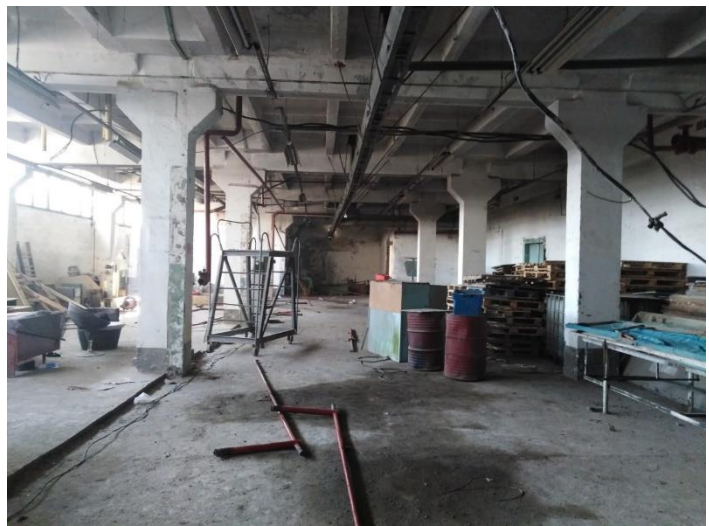
Figure 2 - Interior view of the building
