## Research Article

# EXPERIMENTAL RESULTS ON THE EFFECTIVENESS OF AN IMPROVED EXCAVATOR BUCKET TOOTH DESIGN

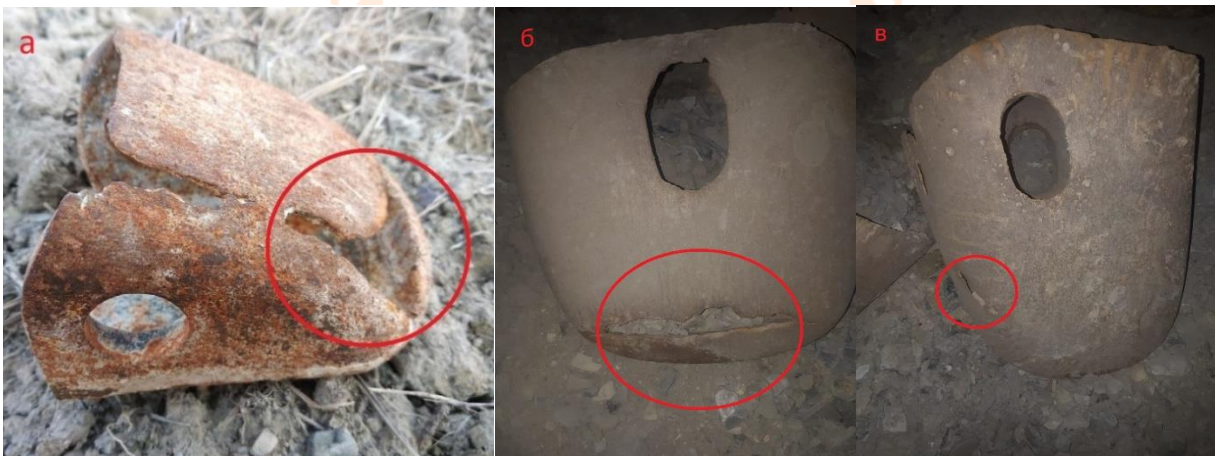
**Figure 2: Perforations in the bucket teeth of the HITACHI EX-1200 excavator as a result of erosion: a - front and side perforation; б - front perforation; в - side perforation**

In many cases, the permissible dimensions of the bucket cutters are not taken into account in the operation of quarry excavators. As a result, the teeth

wear out beyond the allowable level and, over time, holes appear in the teeth (Fig. 2 a, б, в).

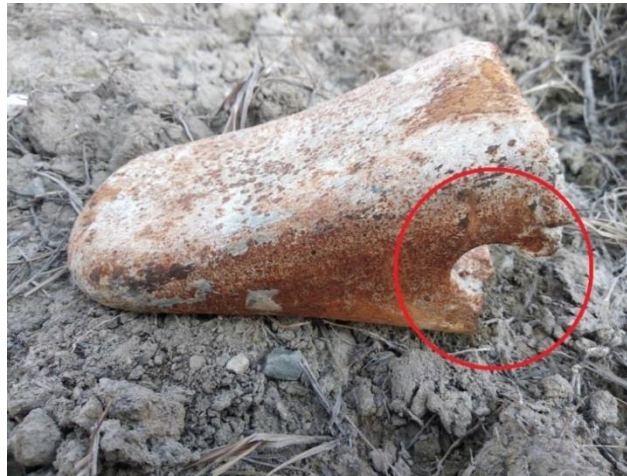
In addition, the brittleness of the materials of the cutting bodies of quarry excavators, the quality of the preparation process technology and the occurrence of badly blasted rock during excavation cause tooth failure due to high stresses in the teeth (fig. 3).

**Figure 3: Fracture of the teeth of the backhoe bucket**

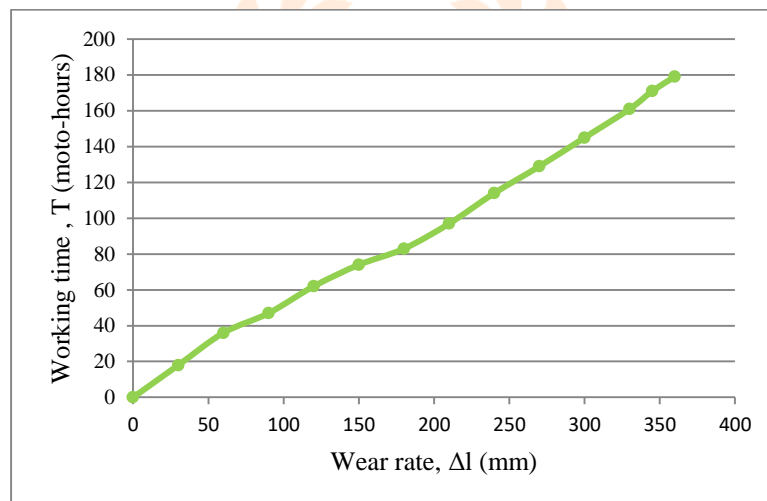
The results of the performance of the new excavator bucket tooth designs developed during the experimental and test work were also recorded, and based on these results the dependence of the operating time of the 5-rhombic excavator bucket tooth shape on the wear size was established, and this dependence is shown in Figure 10 below.

**Figure 10. Flowchart of the wear rate of the improved diamond shaped bucket teeth versus operating time**

As can be seen from the graph of the working time of the improved bucket tooth and the wear value, shown in Figure 10 above, there is an increase in the wear value of the tooth as the operating time of the excavator increases. Thus as a result of increase of operating time every 30 hours the value of wear on length of the bucket's improved tooth was 11-18 mm during the initial working hours of the tooth, i.e. up to 150 hours. During the next 150-360 hours of work every 30 hours the amount of the wear was 11-16 mm on the length of the tooth.

The operating time of the excavator for the permissible length of the improved five diamond-shaped relief teeth of the excavator bucket was 360 moto-hours.
