## Research Article

# DEVELOPMENT OF A NEW DESIGN OF CUTTING ELEMENTS FOR QUARRY EXCAVATOR BUCKETS AND RESULTS OF ITS EXPERIMENTAL RESEARCH

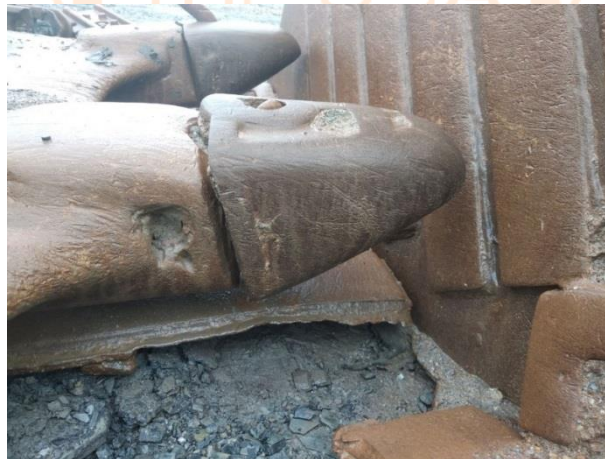
Figure 1. Defective part of HITACHI EX-1200 excavator bucket connected with cutting element and adapter part

Fault 1, shown in Figure 1, results in additional resistance to cutting and drilling due to the fingers not being fastened to the required standard in the

fastening part of the cutting element and the adapter part of the bucket. In case of failure 2, due to the poor quality of the cutting element and the adapter part, the

tooth is in a cold state and as a result does not sink well into the rock [4].

Figure 1 shows the faults of the HITACHI EX-1200 quarry hydraulic excavators connected to the cutting elements and the adapter part of the bucket.

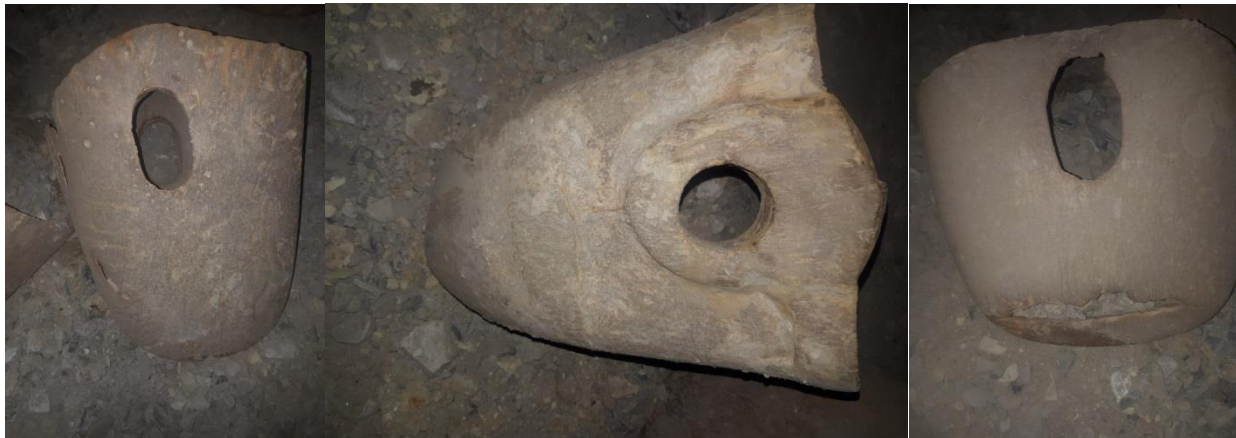
elements is ignored. This can lead to tooth decay beyond the allowable level, which can eventually lead to tooth decay, and these defects are shown in Figure 2.

Figure 2. Perforation of HITACHI EX-1200 excavator bucket teeth due to erosion

Faults caused by untimely maintenance of teeth can lead to malfunctions in other systems, which are even greater. As a result of research and analysis in production, tooth perforation also leads to rapid wear of the adapter part, and these processes reduce the efficiency of quarry excavators and increase operating costs [5].
