## Analysis Of The Results Of Natural Studies Of Hydraulic Turbines Of Hydroelectric Power Stations

### ABSTRACT

The paper deals with the issues of hydroabrasive wear of hydraulic turbines of hydroelectric power stations that arise in the river water of suspended and bottom sediments. Sediments, accumulating on water conduits and regulating tanks, significantly complicate and worsen the operation of hydroelectric power stations. The results of the impeller of hydroelectric power stations and measures to combat intensive wear of hydraulic turbines used under difficult operating conditions are presented.

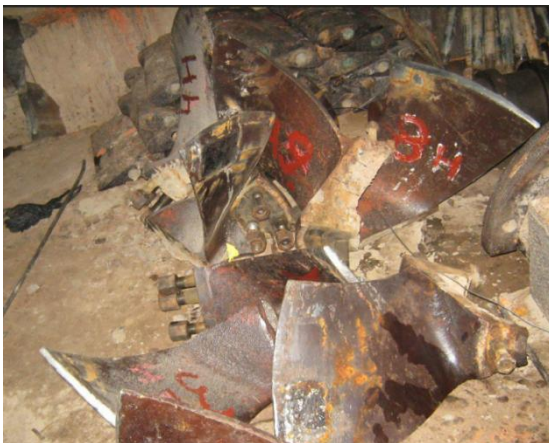
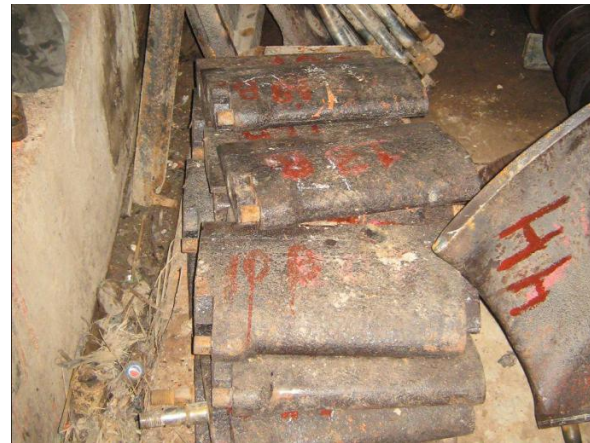
Figure: 1. The impeller of the hydroelectric power station

As practice shows, when operating hydraulic turbines under conditions of hydroabrasive wear, the frontal parts of the impeller blades, the outer part of the guide vanes and the inner part of the housing are exposed to the most intense impact. Figure 1 shows the worn-

out parts of the hydraulic units of the Cascade of Tashkent HEPS (Sheikhantakhur HEPS). Sheikhantakhur HEPS, which is a part of the Unitary Enterprise "Cascade of Tashkent HEPS", is located within the fourth above-floodplain terrace of the Chirchik river on the Bozsu canal and is the second stage of the cascade of Tashkent HEPS. The nature of blade damage in these figures indicates fine-flaked wear with sparse, separately located, shallow flakes and a deep (deep) type of wear with long grooves. This indicates the presence of hydroabrasive wear of the parts of the hydraulic turbines of the Sheikhantakhur HEPS. Quantitatively and qualitatively, this waterjet wear can be attributed to low and medium activity. Despite the presence of the process of hydroabrasive wear, the main

reason for the drop in energy efficiency should be considered the general physical wear associated with the long period of operation of the hydraulic units and their obsolescence (it was mentioned above about the outdated type of hydraulic turbines - rotary radial).
